United States
Circuit Court of Appeals
For the Ninth Circuit.

UNITED STATES OF AMERICA,
Appellant,

J. LESLIE MORRIS COMPANY, INC., a cor-
poration,
Appellee.

Transcript of Record
(Plaintiff's Exhibits 1 to 32)

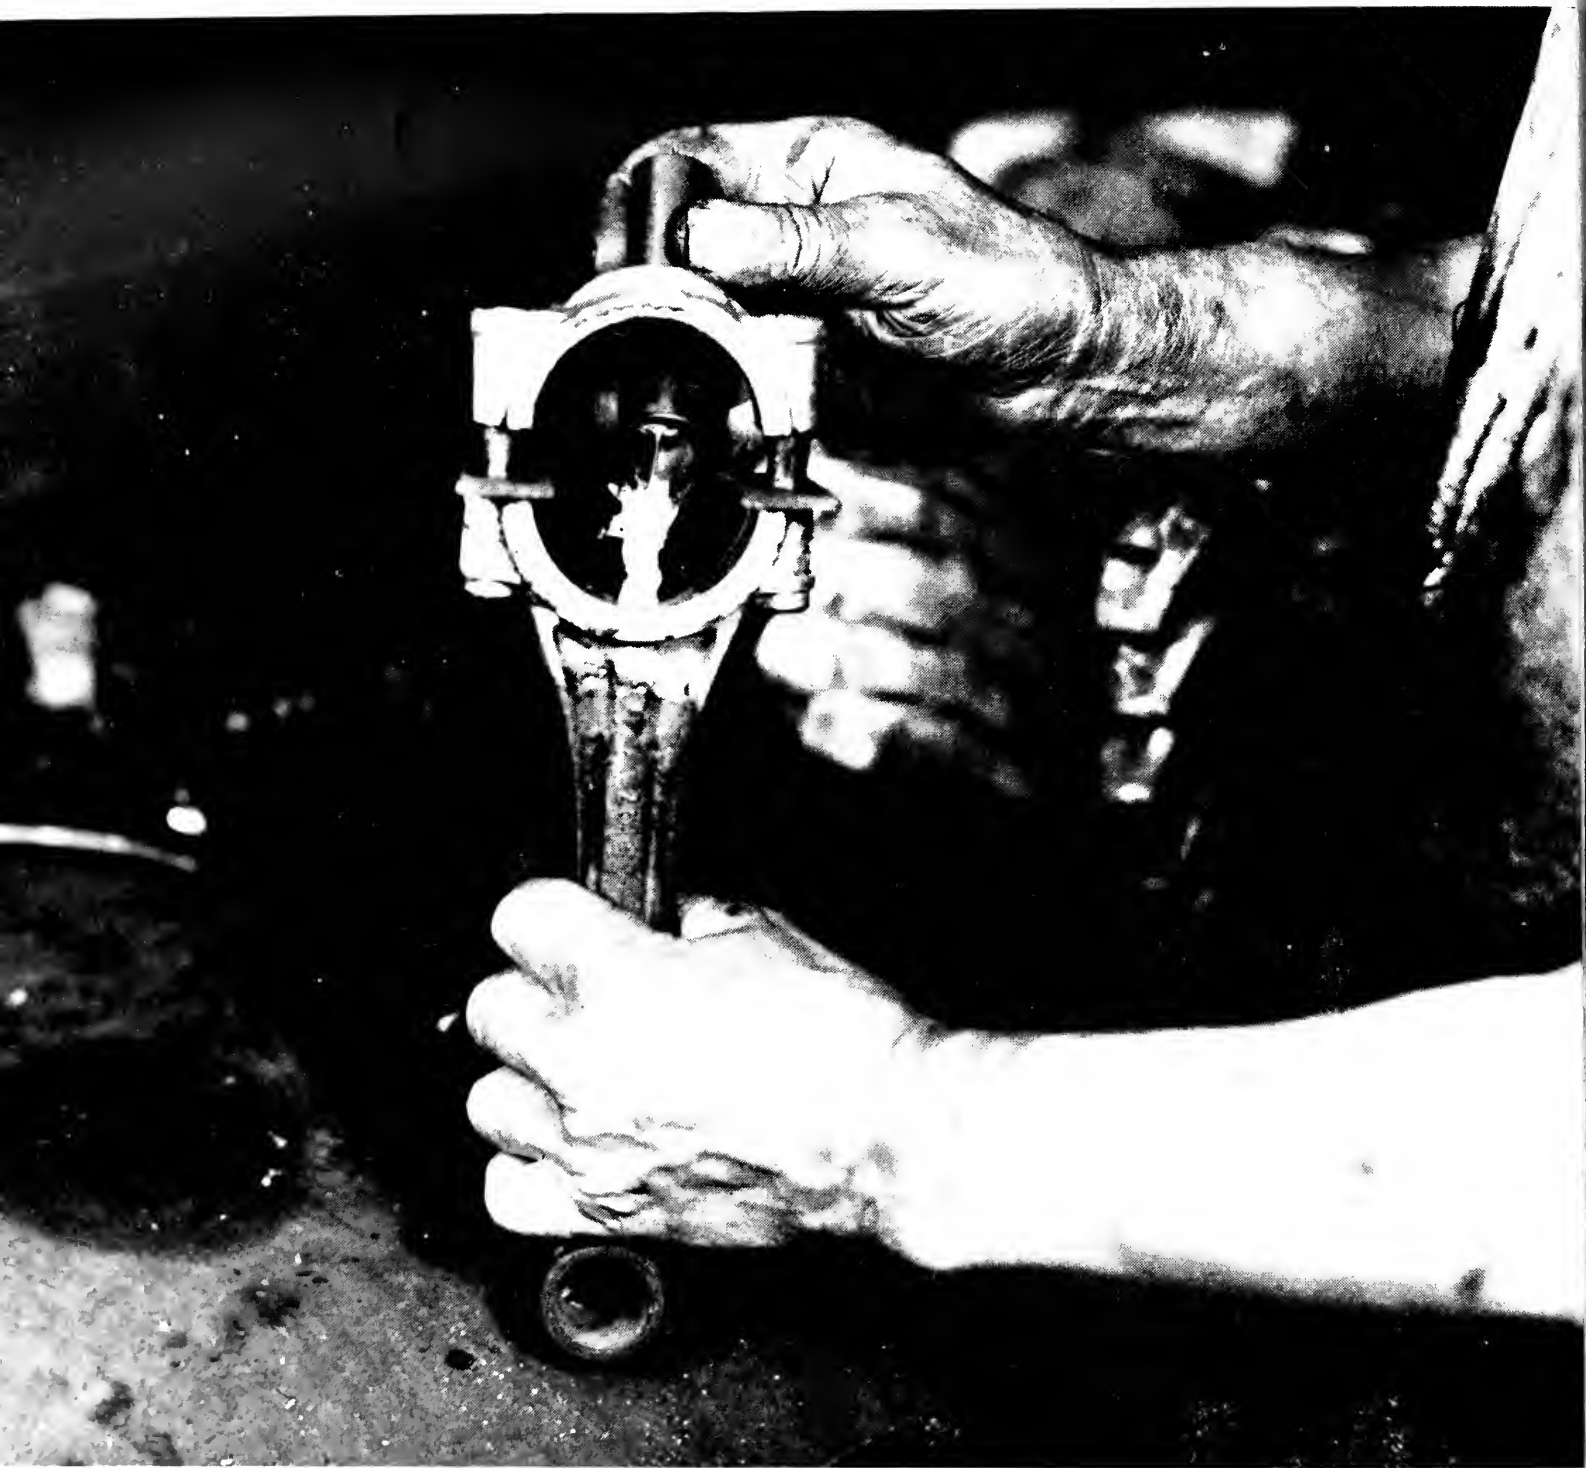
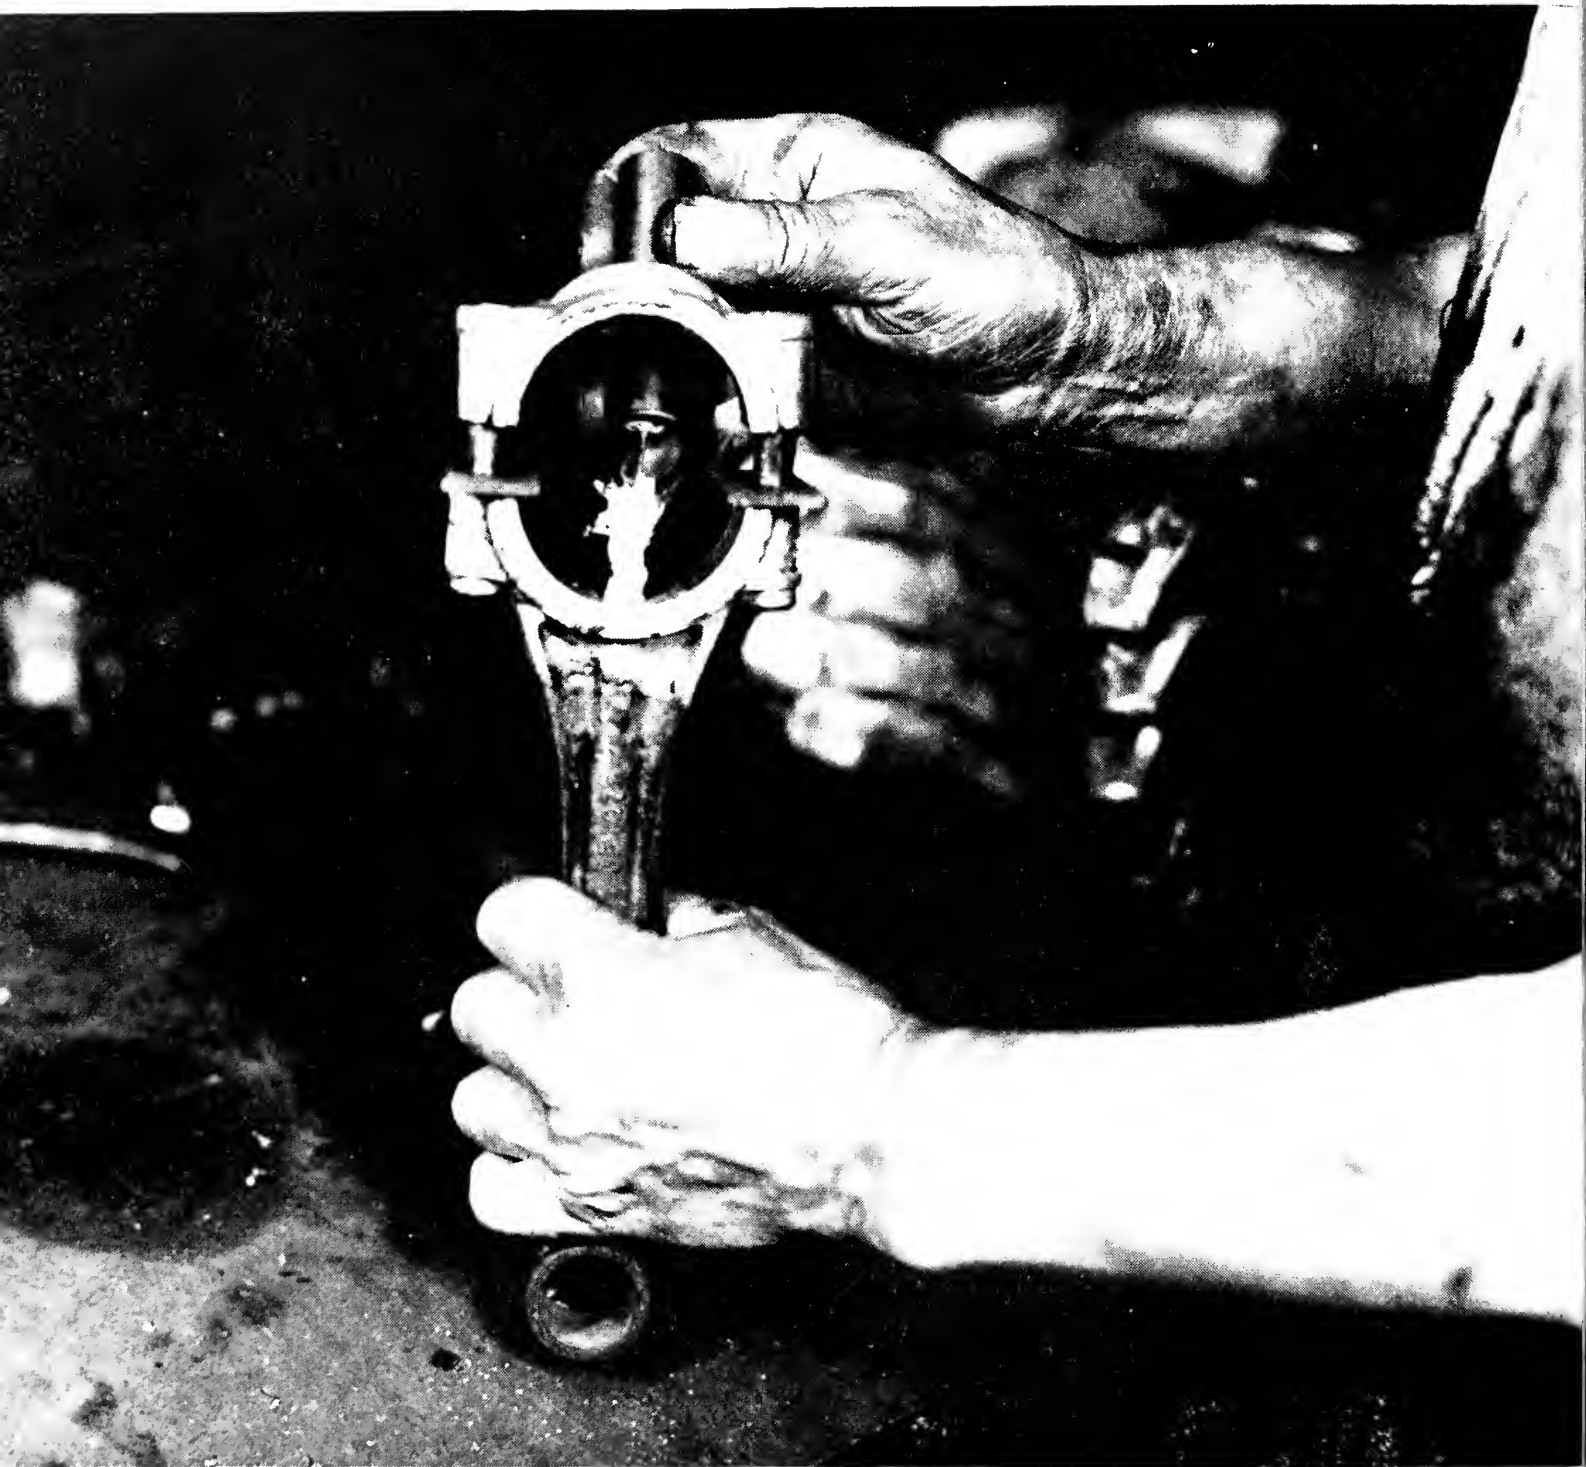
PLAINTIFF'S EXHIBIT No. 10

Any oil holes appearing in various places on the cap or the bearing end of the rod (varying with the type of rod) are plugged with asbestos wicking as shown above. In some instances small cork stoppers are used and even toothpicks on the smaller rods. This caulking process prevents the labbitt from plugging up the oil holes.

Any oil holes appearing in various places on the cap or the bearing end of the rod (varying with the type of rod) are plugged with asbestos wicking as shown above. In some instances small cork stoppers are used and even toothpicks on the smaller rods. This caulking process prevents the babbitt from plugging up the oil holes.

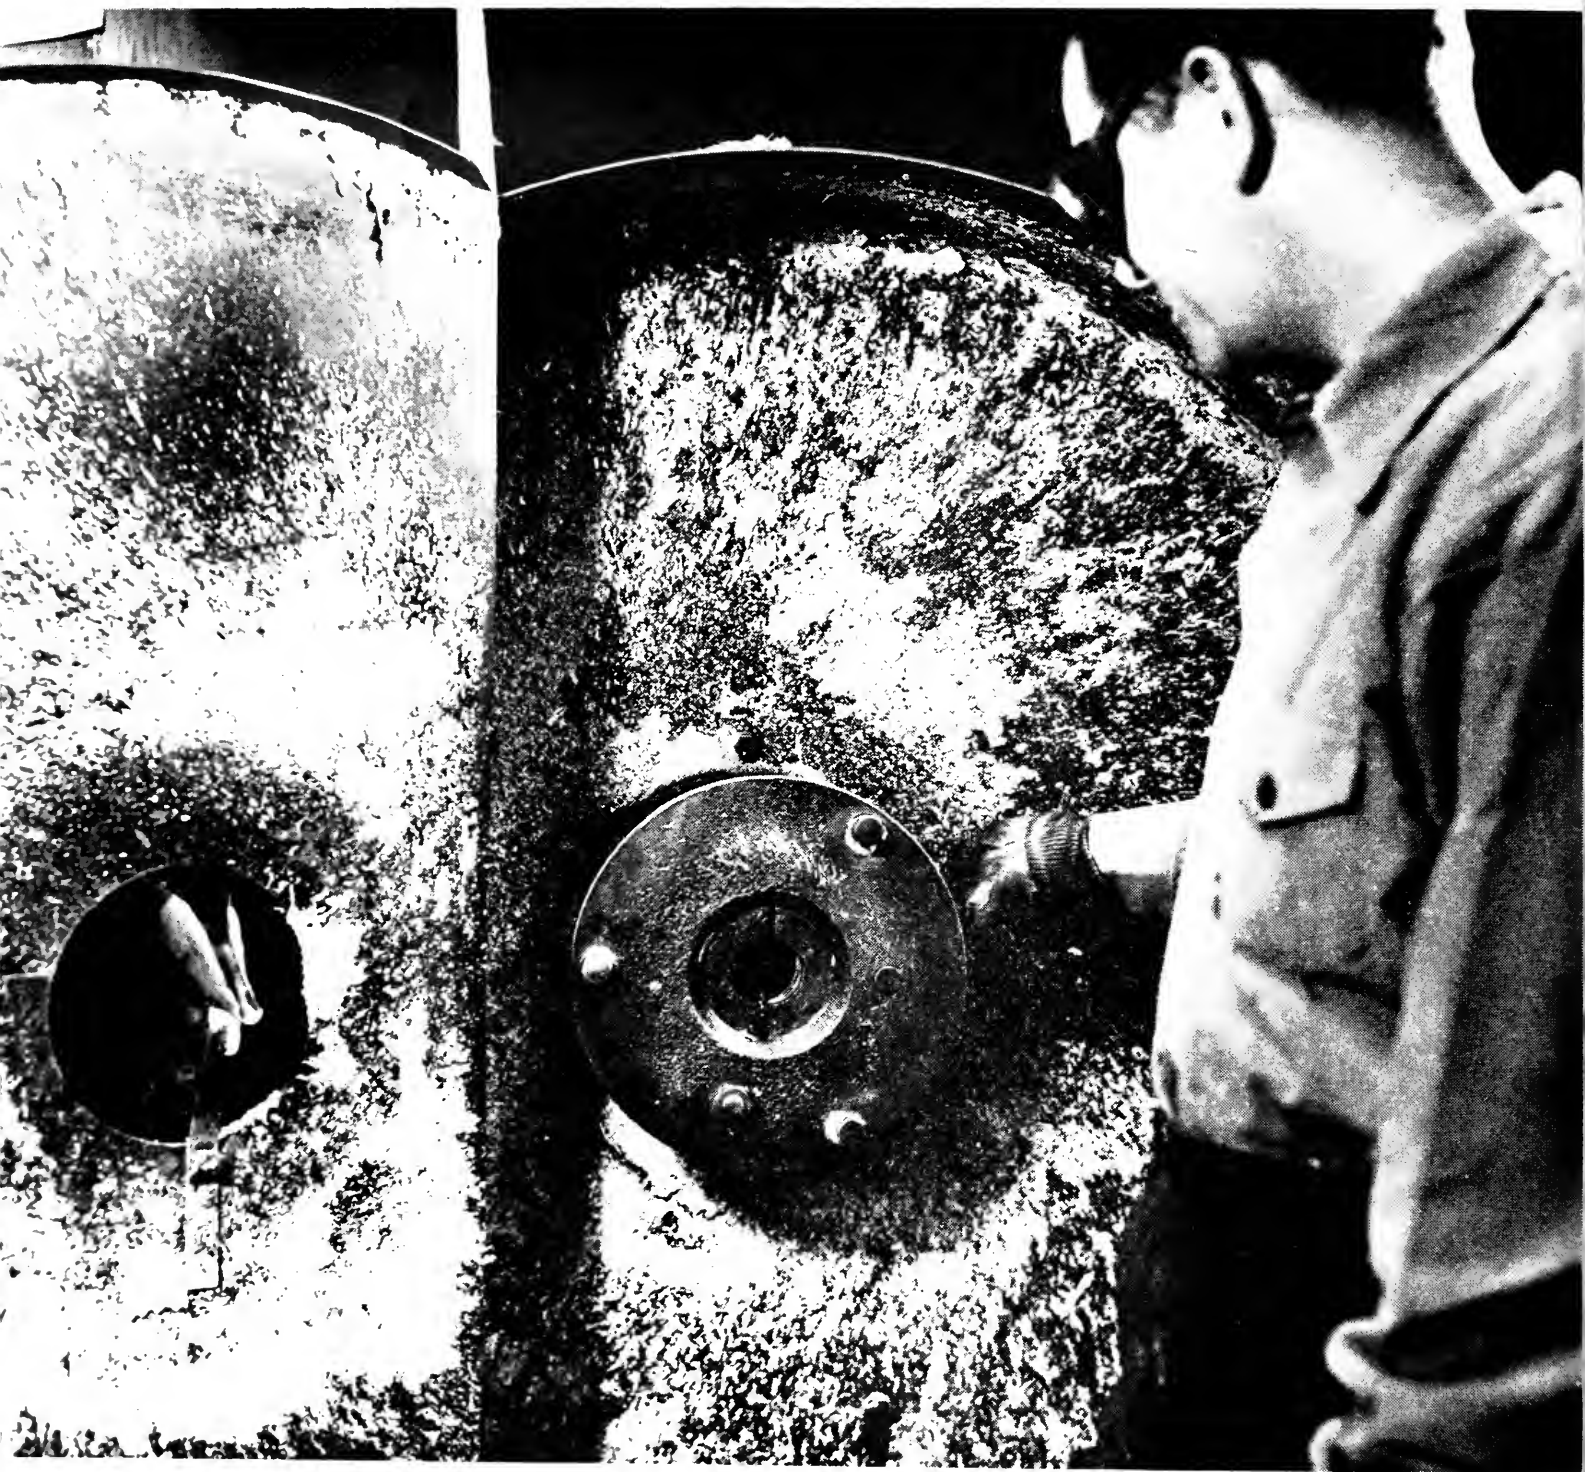
PLAINTIFF'S EXHIBIT No. 11

The rods are then taken to the centrifugal casting machines which were built by Plaintiff corporation for its own use. There are two of these machines because it takes the babbitt about fifteen seconds to cast and thus one operator can run the two machines. Each of these centrifugal casting machines consists of a revolving shaft on which is mounted a mold holder shown above. This mold holder is opened by means of a foot lever and the bearing end of the rod is placed between the molds which cup over each side of the bearing end. The illustration above shows the operator with his right hand covering the shank end of the rod with the bearing end in between the open mold. When the foot lever is released the outer part of the mold seen in the picture snaps back against the bearing end of the rod holding the rod securely so that it makes a perpendicular axis to the shaft on which the mold holder is mounted.

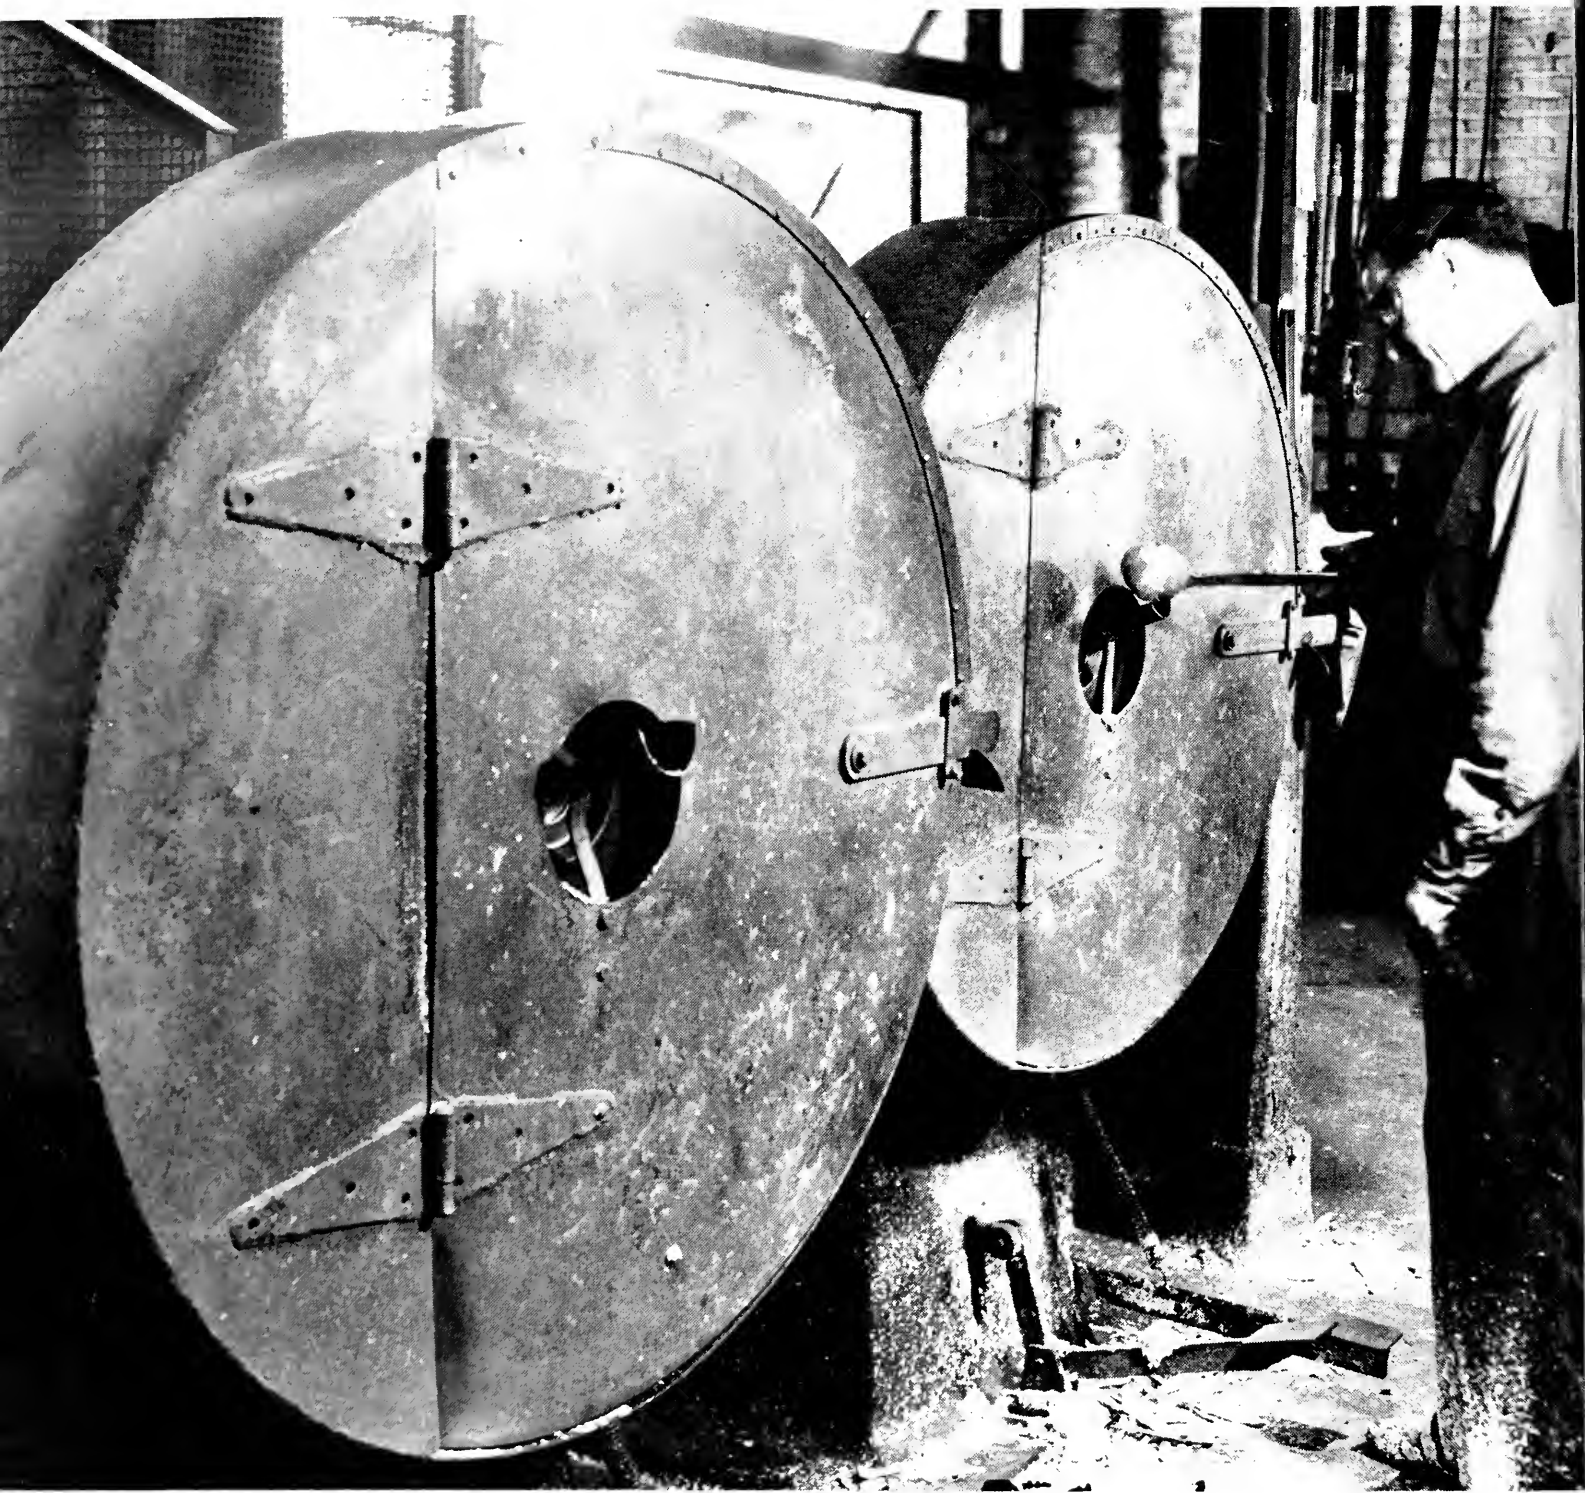
PLAINTIFF'S EXHIBIT No. 12

The mold holder is incased inside a pancake shaped container which is mounted perpendicular to the floor. The center of the door to the container has a hole in it approximately eight inches in diameter. Through this aperture a small trough is affixed as shown above. The small end of the trough leads down into the outer face of the mold which is open. Then when the rod has been set in the mold holder as previously described, the door of the container is closed, and by means of a foot lever the shaft and mold start to revolve spinning the rod with the bearing end as an axis. As the shaft, mold and rod are spun, an operator pours molten babbitt into the trough. The babbitt runs down into the bearing end of the rod and the centrifugal force spreads it evenly over the inside curved surface of the bearing and of the rod.

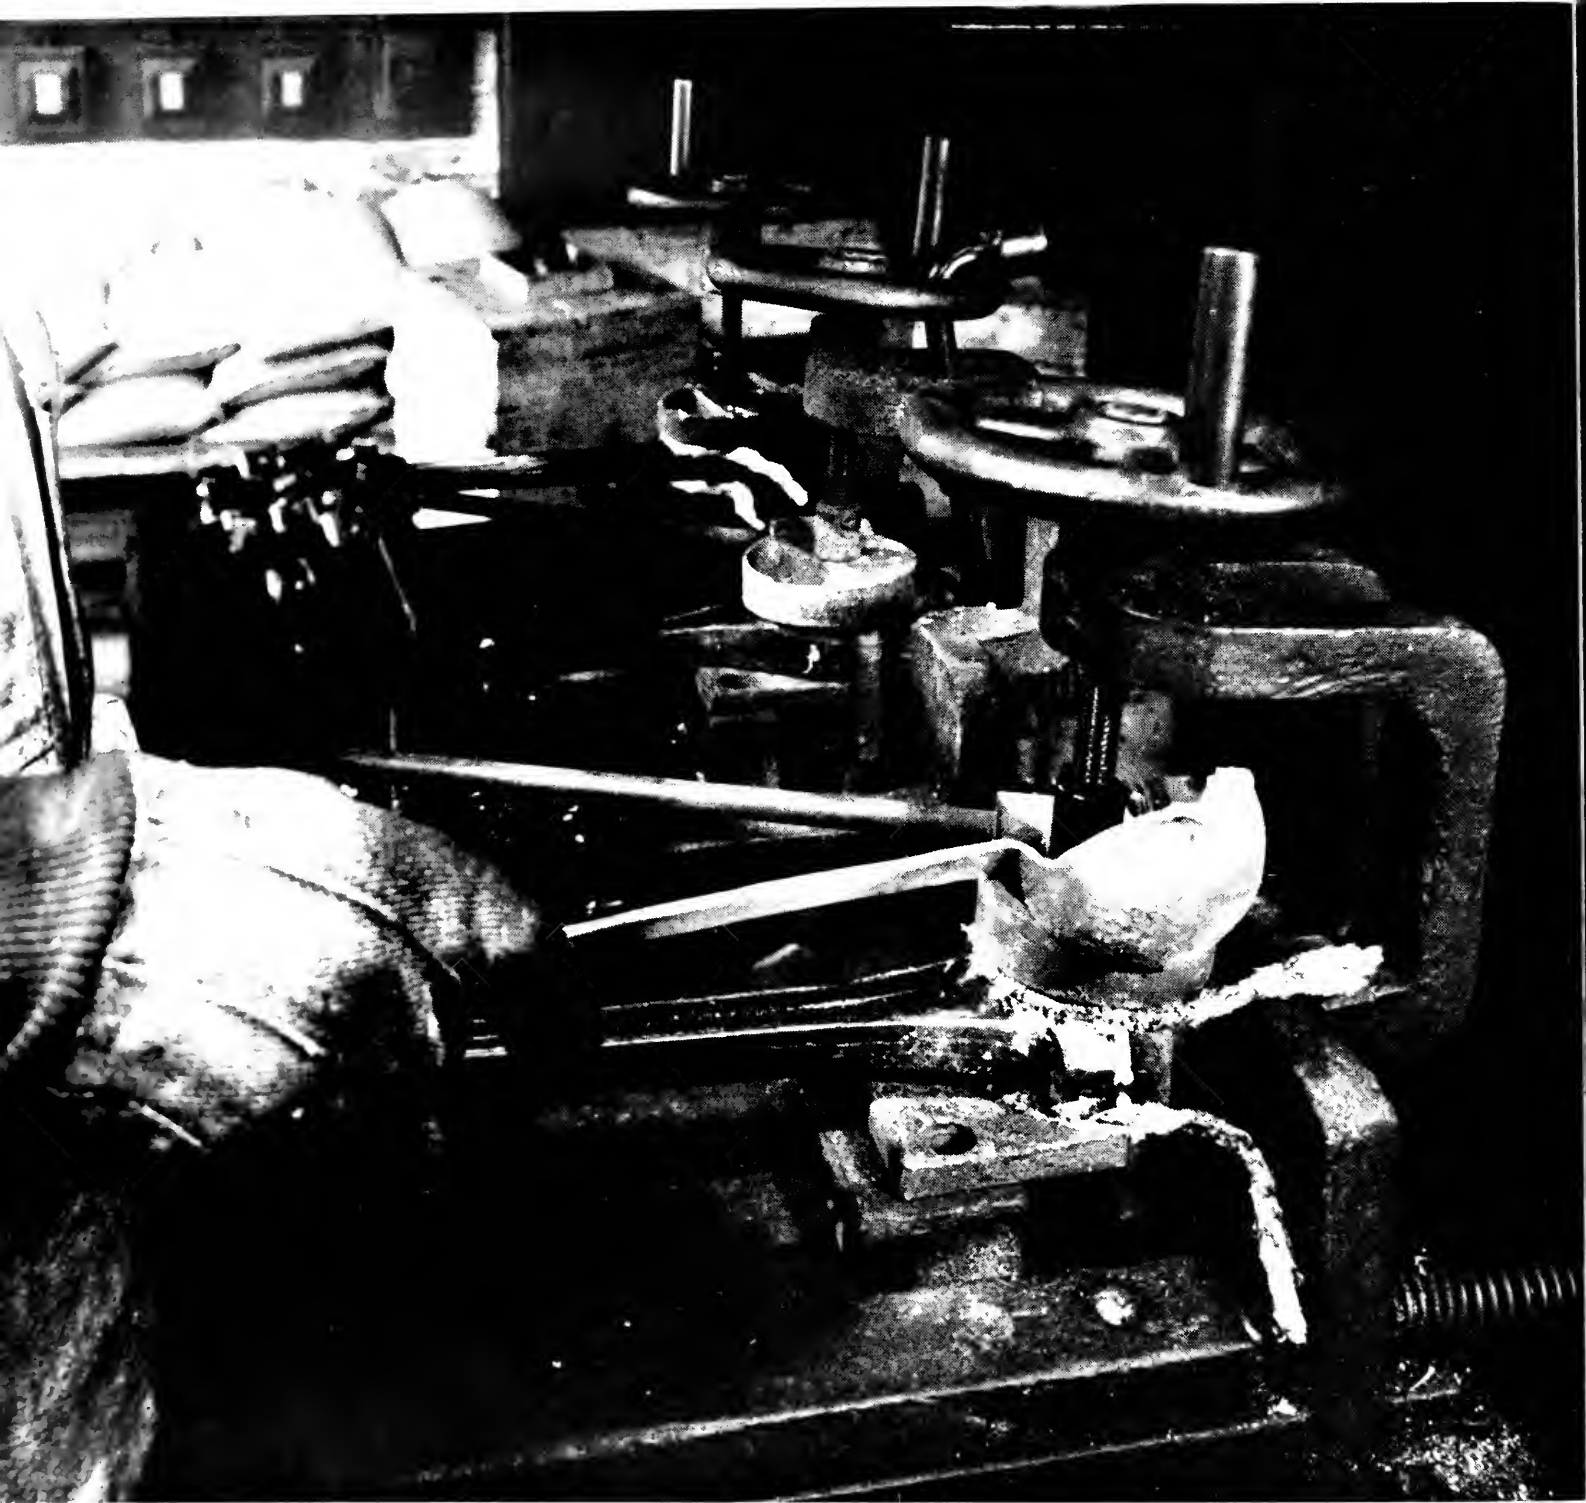
PLAINTIFF'S EXHIBIT No. 13

A certain percentage of the rods must be rebabbitted by hand—about 20%.

In this operation the man who does the hand-casting dips his own rods in the acid and tin for the reason that the place where he works is too far away from the ordinary dipping pit. In the hand-casting the cap is cast separately from the shank by placing either the cap or the shank flat between two molds which cup on each side of either the shank or cap. Between the rod and the mold there is wedged an asbestos wicking to prevent leaks; then the operator pours the molten babbitt through a hole in the top of the mold and it drops through to the inside of either the cap or the shank, whichever part is being babbitted. The surplus babbitt is then chipped off by an operator.

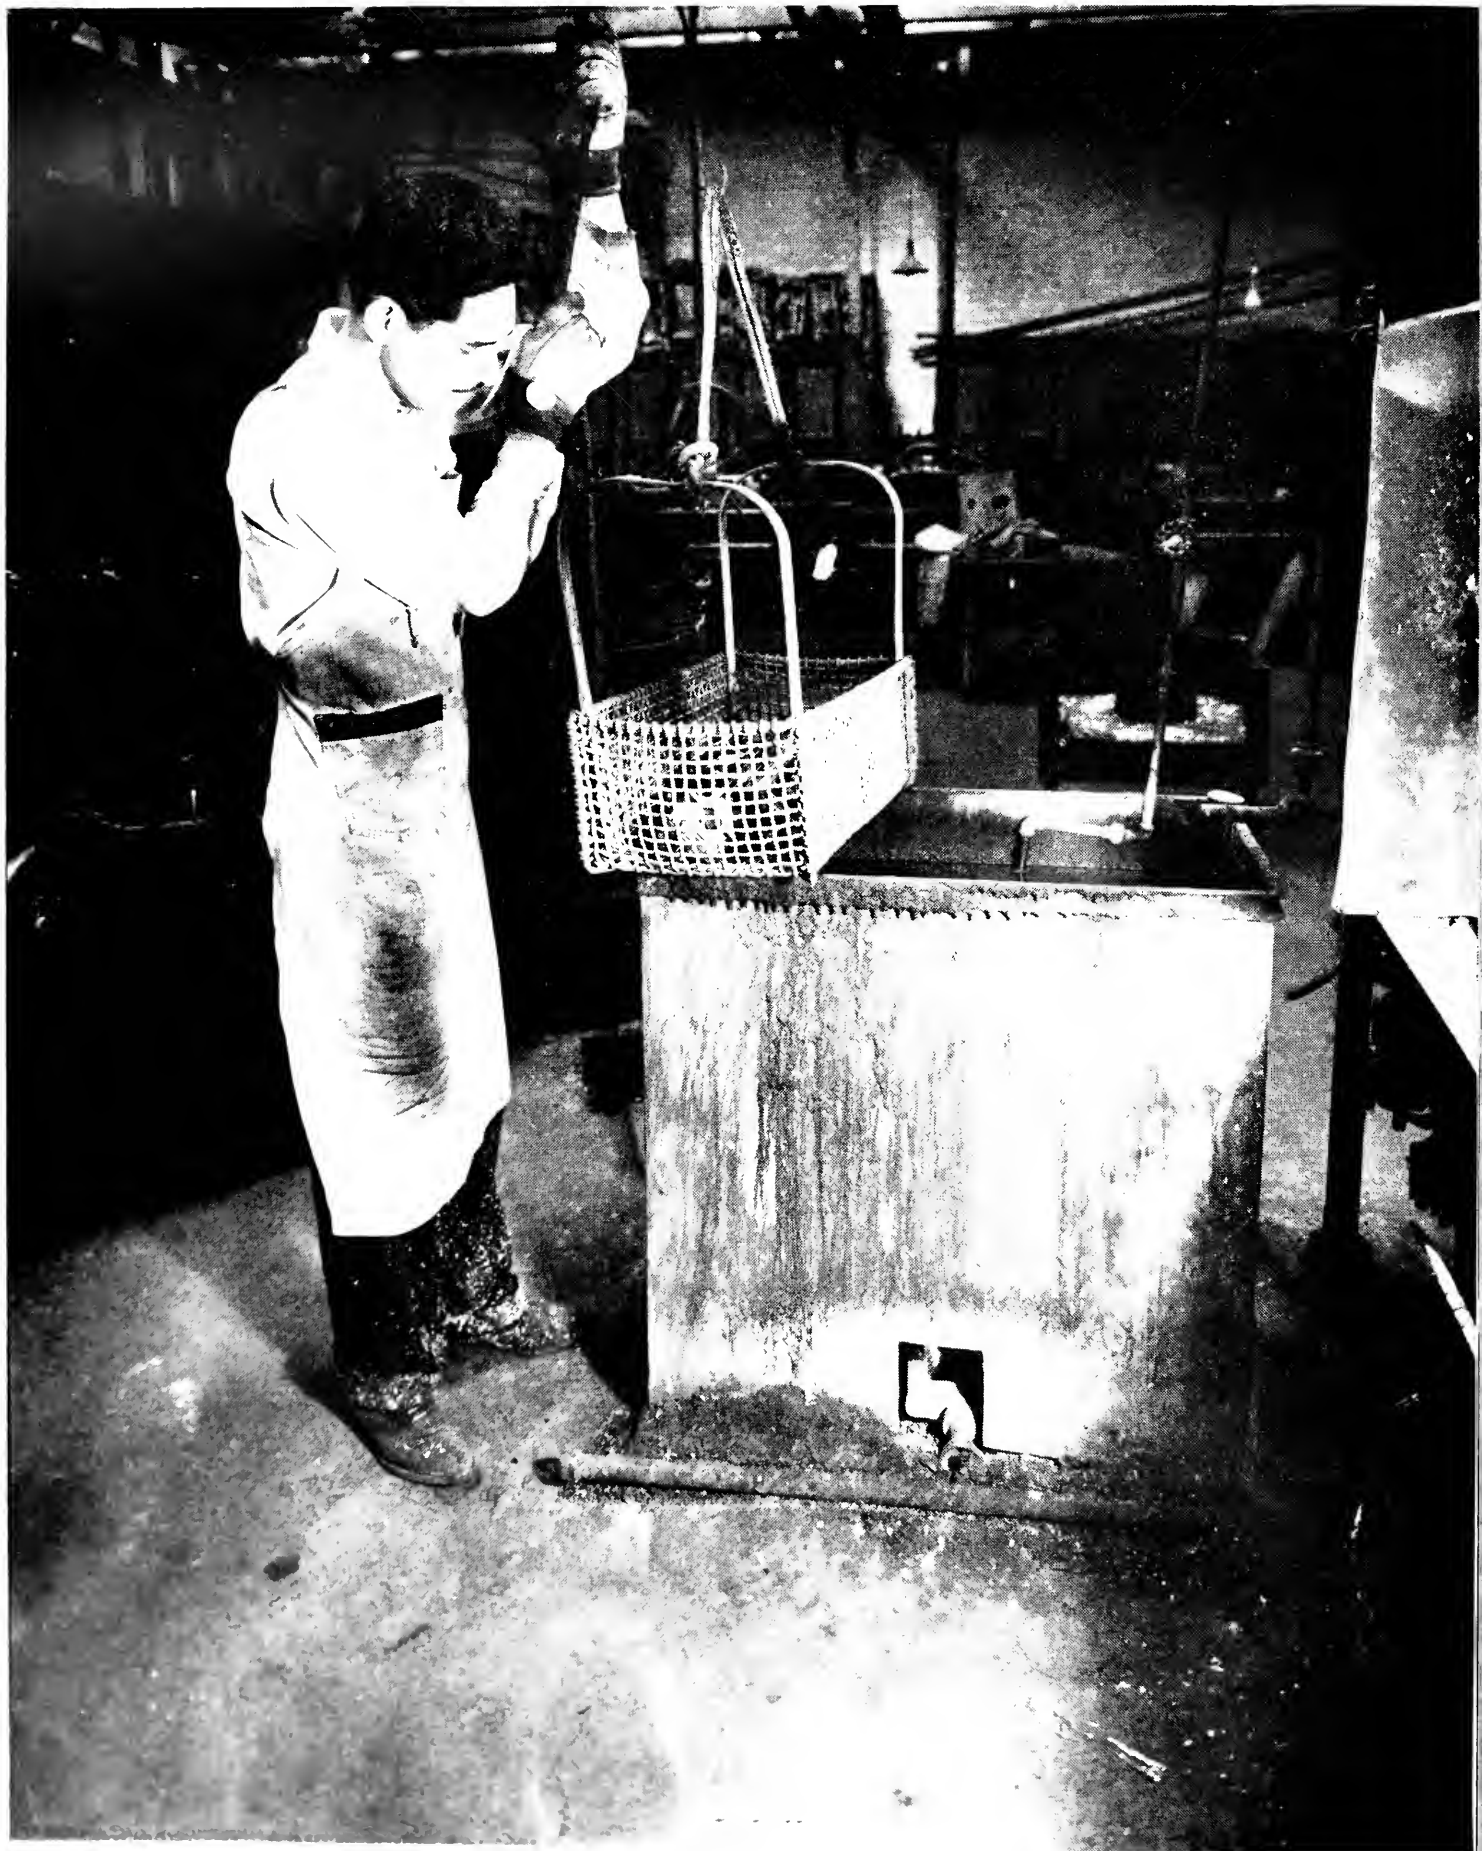
PLAINTIFF'S EXHIBIT No. 14

Then the rods are dipped into an oakite tank as shown above for cleaning.

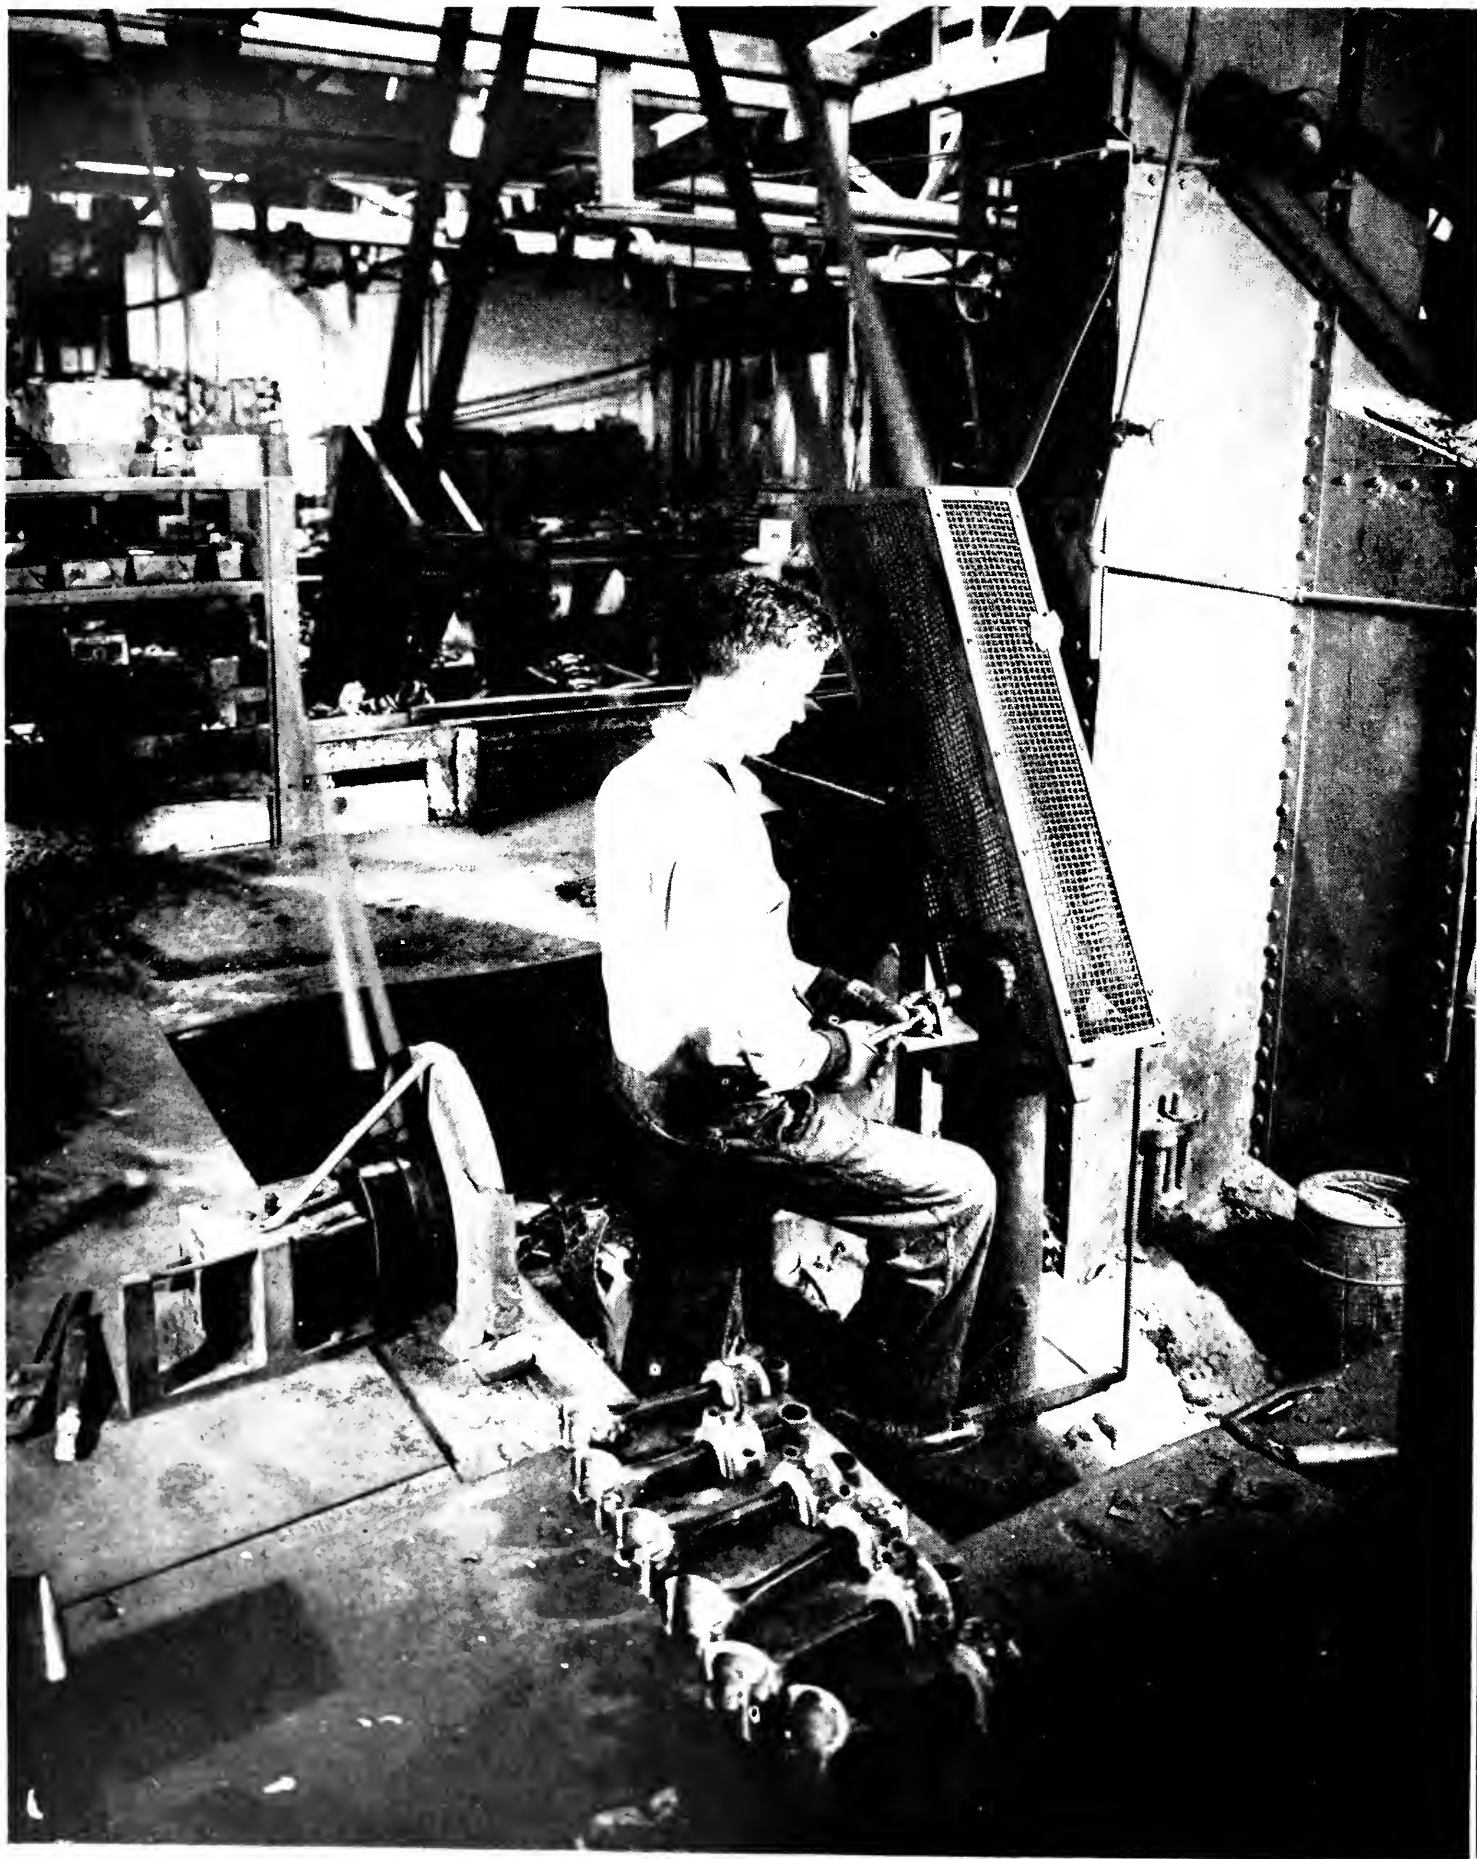
PLAINTIFF'S EXHIBIT No. 15

Then the steel separator shims are removed by the means of the socket wrench shown in picture number five, and any auxiliary nuts and bolts are removed and the originals replaced.

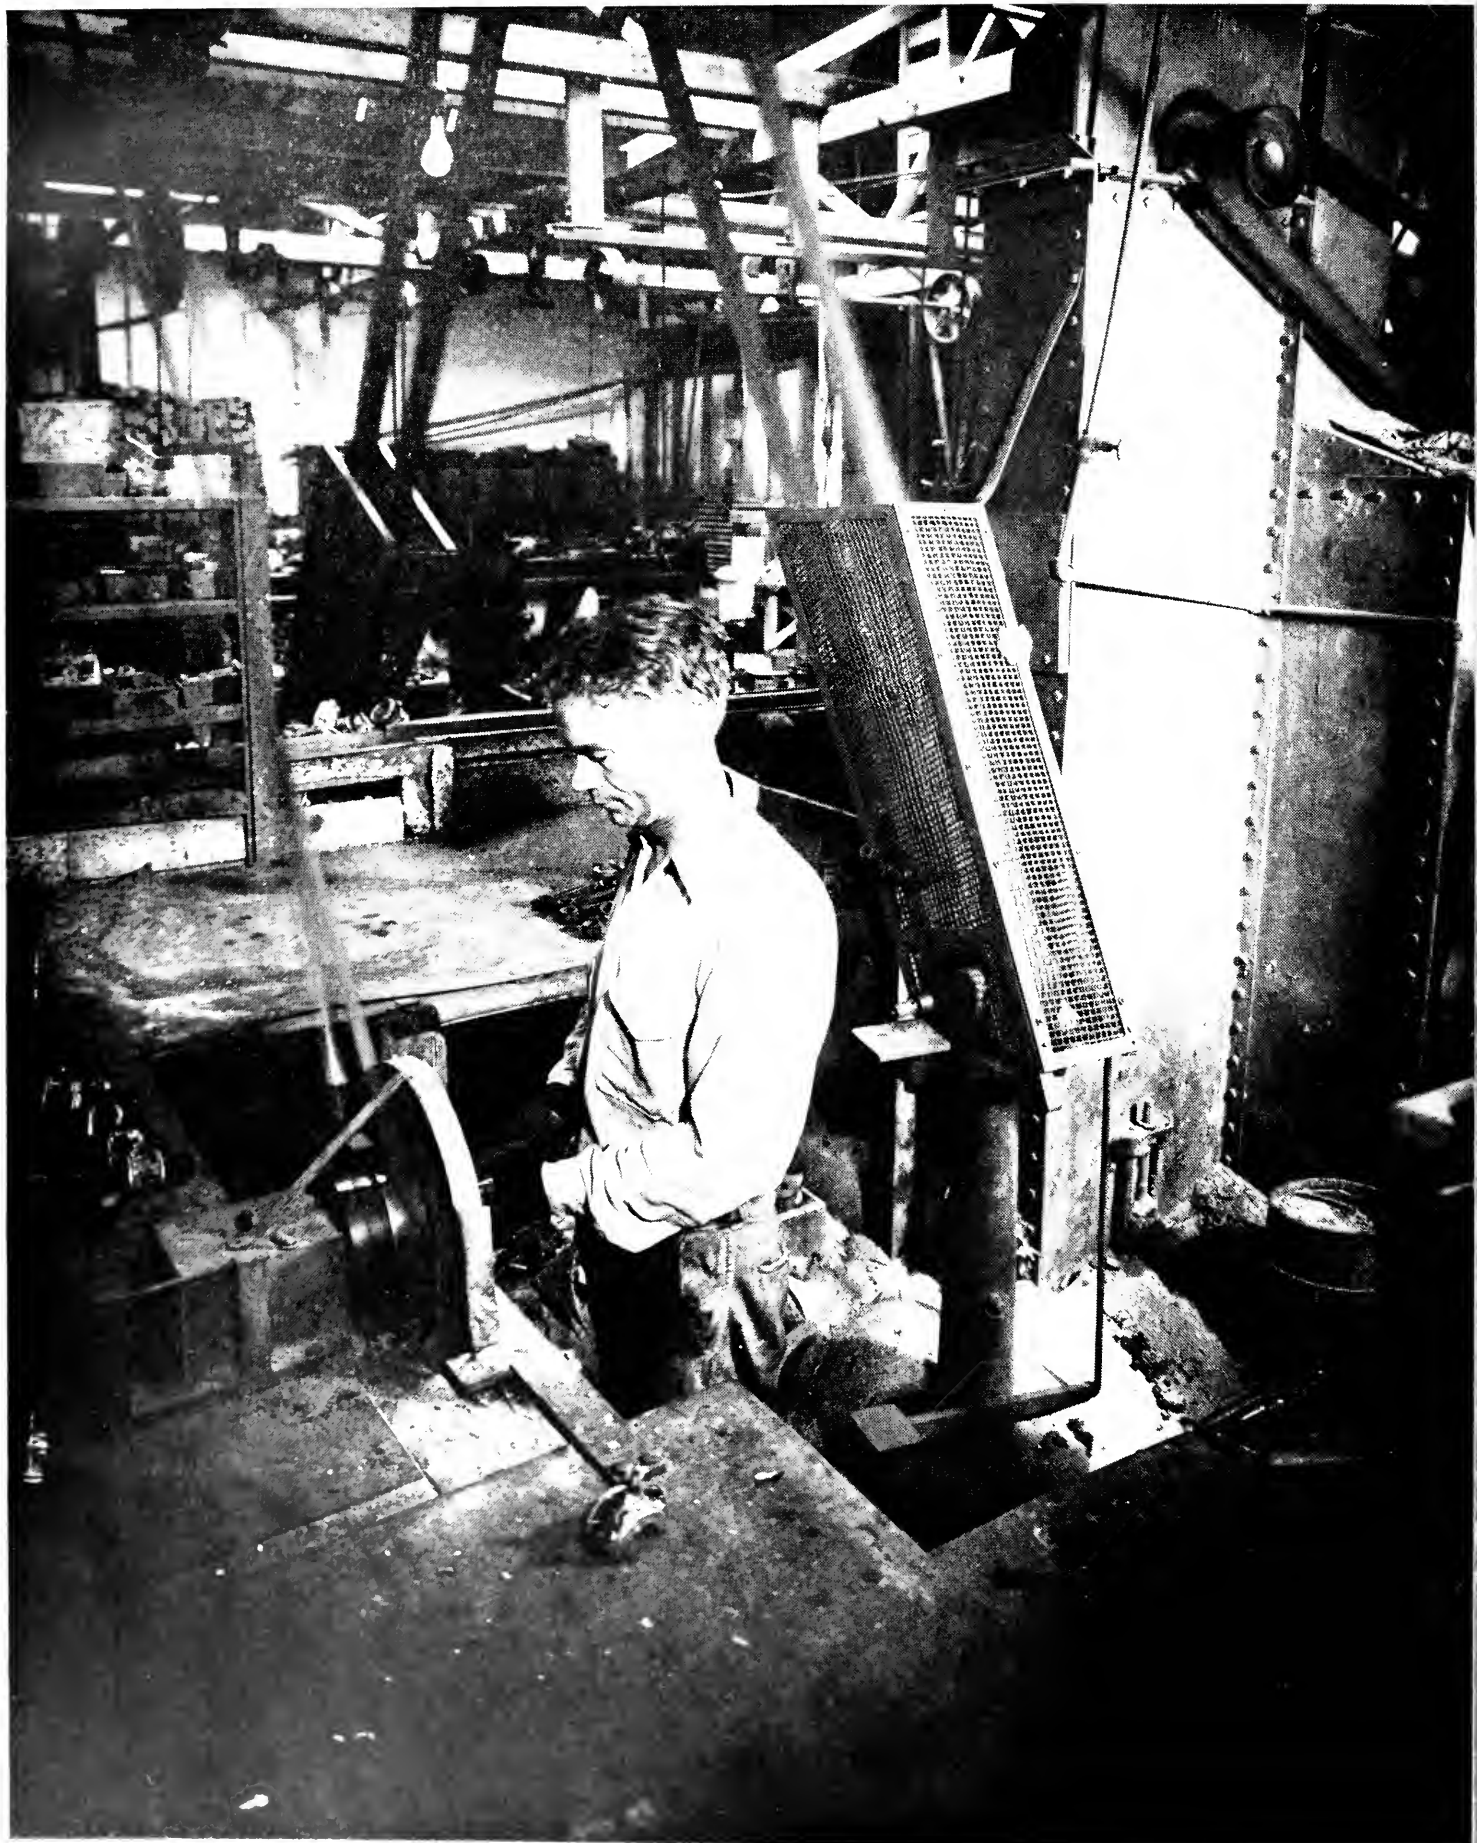
PLAINTIFF'S EXHIBIT No. 16

However, before the cap is fastened to the bearing end of the rod any ragged edges of babbitt which may have adhered where the shims separated the cap from the bearing end of the rod are removed by holding the open face of the cap or the open face of the bearing end of the rod against the revolving sandpaper disc as shown above.
